NASA Contractor Report 166012

FULL-SCALE TESTING, PRODUCTION, AND COST ANALYSIS DATA FOR THE ADVANCED COMPOSITE STABILIZER FOR BOEING 737 AIRCRAFT

VOLUME II—FINAL REPORT

December 1982

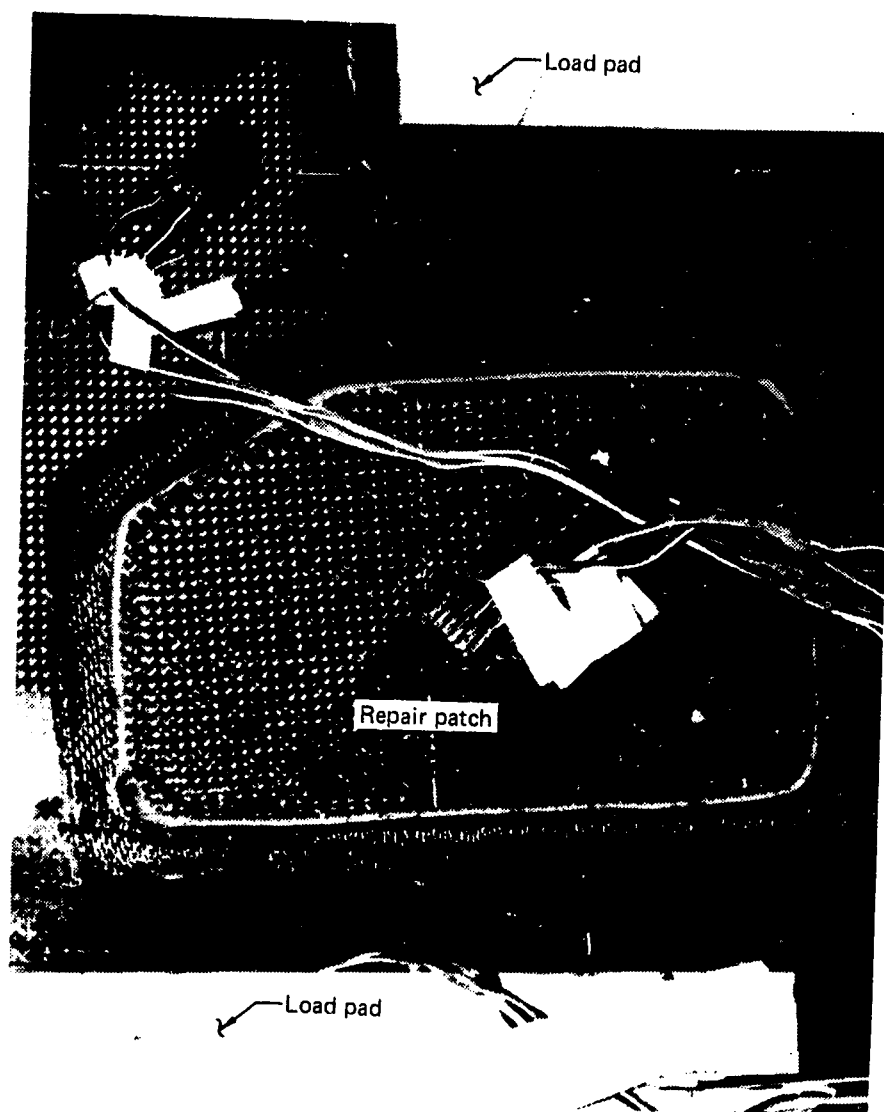
Figure 16. Lower Surface Skin Repair—Station 111.1, Stringer 10

Loading was stopped at 67% of ultimate load case 4761 when high strain readings were noted in the area of inflicted damage at the skin lower surface, stabilizer station 111.10, and stringer 10 (LS 9, fig. 10). Damage in this area was repaired as shown in Figure 16. After the repair was made, ultimate load case 4761 was applied again. Test loading was halted when graphite fiber breakage occurred to the rear-spar upper terminal lug at 94.4% of design ultimate load. Graphite fiber

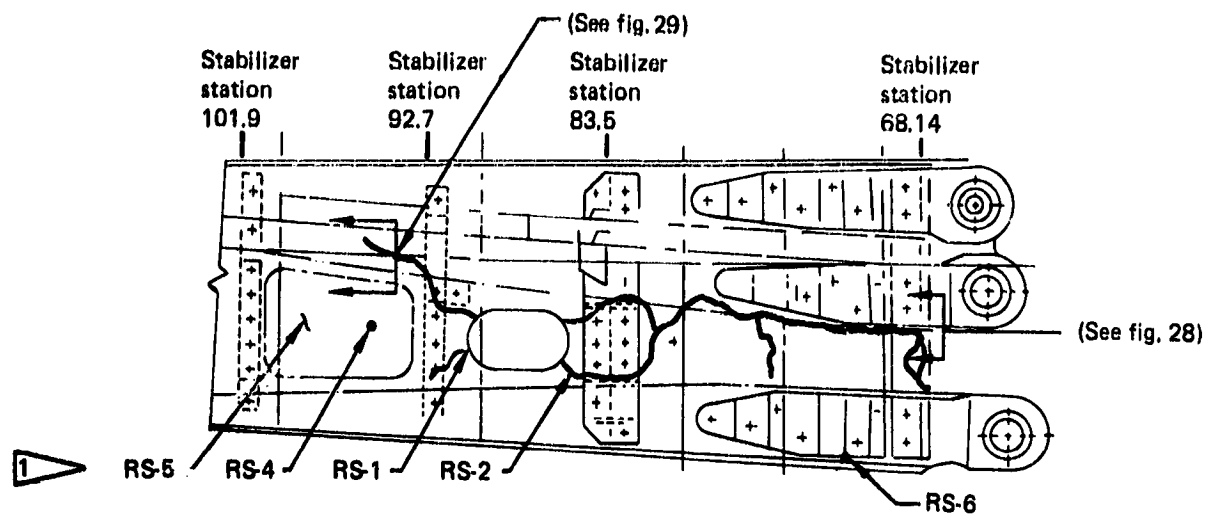
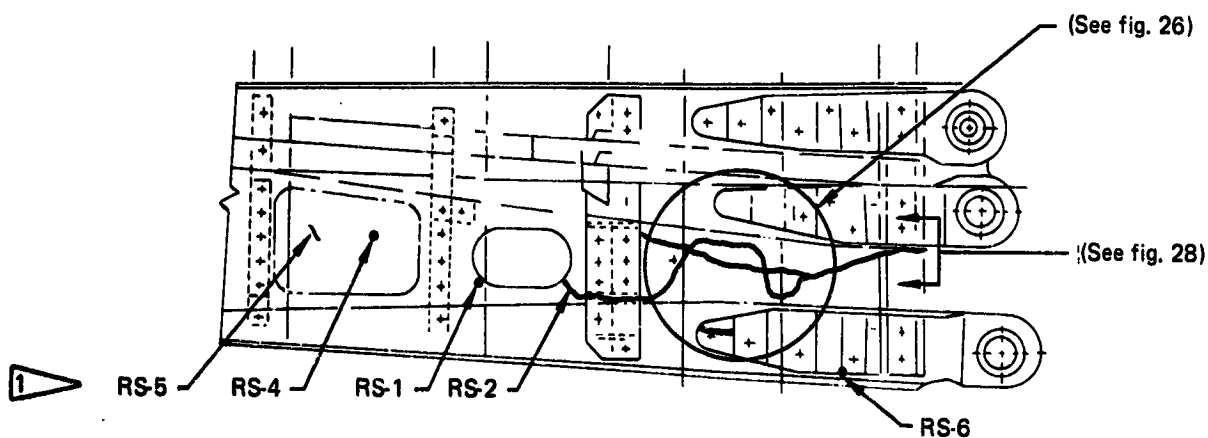
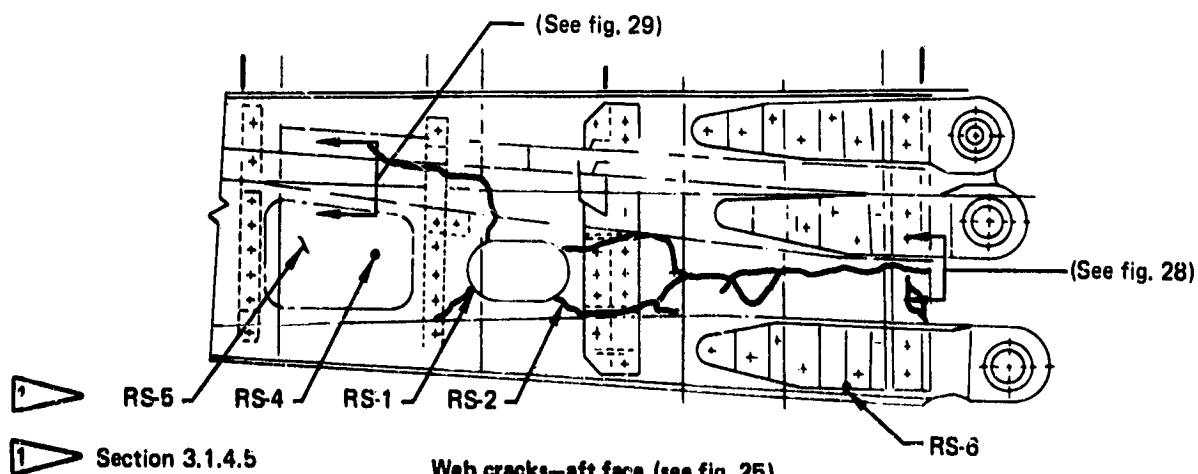
Figure 23. Failure Description

During application of load case 4010 with the rear-spar upper pin removed, a shear failure of the rear-spar web between stabilizer station 68.14 and 96.0 occurred at 61% of design ultimate load (91% design limit load). The rear-spar failure was initiated by a tension failure of graphite-epoxy fibers in a direct line between the upper fail-safe lug and the lower lug. A description of the failure is summarized in Figure 23, and photos of the details are shown in Figures 24 through 29.

Web cracks—forward face (see fig. 24)

Through-thickness crack

Web cracks—aft face (see fig. 25)

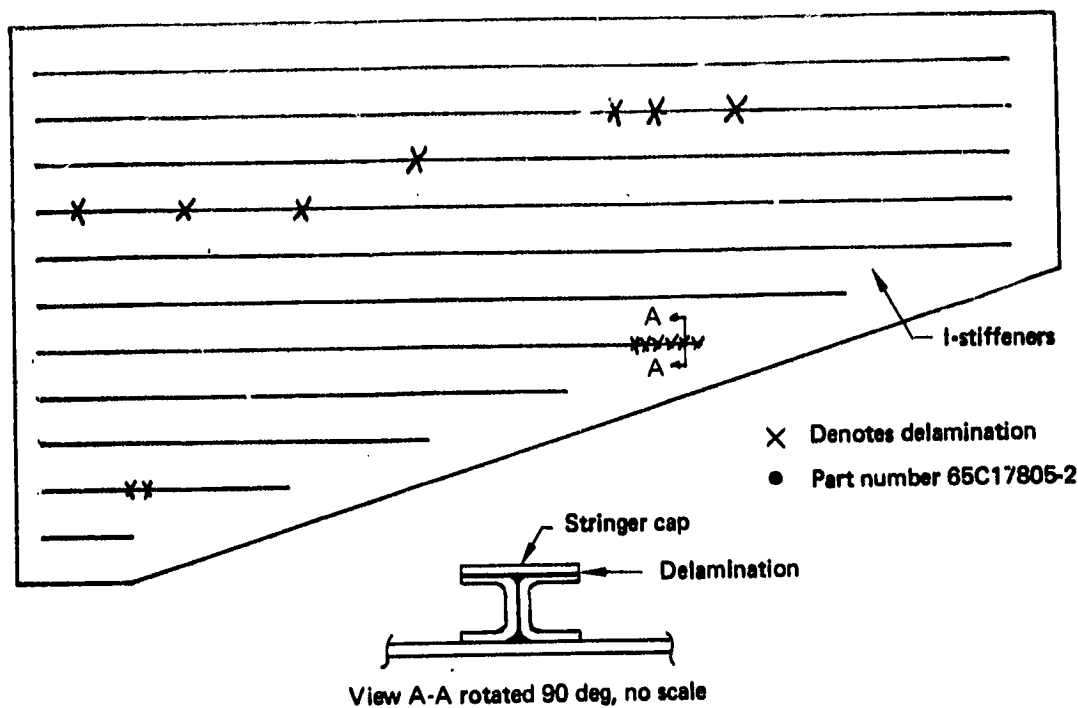
Figure 58. Delamination in Stabilizer Upper Skin Panel

Two sets of test panels were constructed to determine the cause of the problem. The first panel was five stringers wide and 152.4 cm (5 ft) long. Suspected factors tested were material age, bagging techniques, caul-strip buckling, and bond-line contamination. This panel showed no delamination. The age of the material was ruled out as a contributing factor, but it was determined that a full-length panel test was required to fully assess other probable causes. The second panel was six stringers wide, each with a different layup and bagging technique for capping the stringer ends, tying down the aluminum caul strips, and for resin bleeding.

The full-length test panel showed no delamination and established the need for revisions in present layup and bagging techniques to ensure that the condition would not recur. As a result, the full-size production panel was remade with the following changes (fig. 59):
